Highway Accident Brief

Train and Truck Crash on Railroad Right-of-Way and Subsequent Fire

Accident Number: (NTSB) HWY15MH006
Accident Type: Train and truck crash on railroad right-of-way and subsequent fire
Location: Near intersection of East Fifth Street and South Rice Avenue, Oxnard, California
Editing: This is not an official NTSB document. On February 11, James McGillis created this document and claims copyright to its content and conclusions.

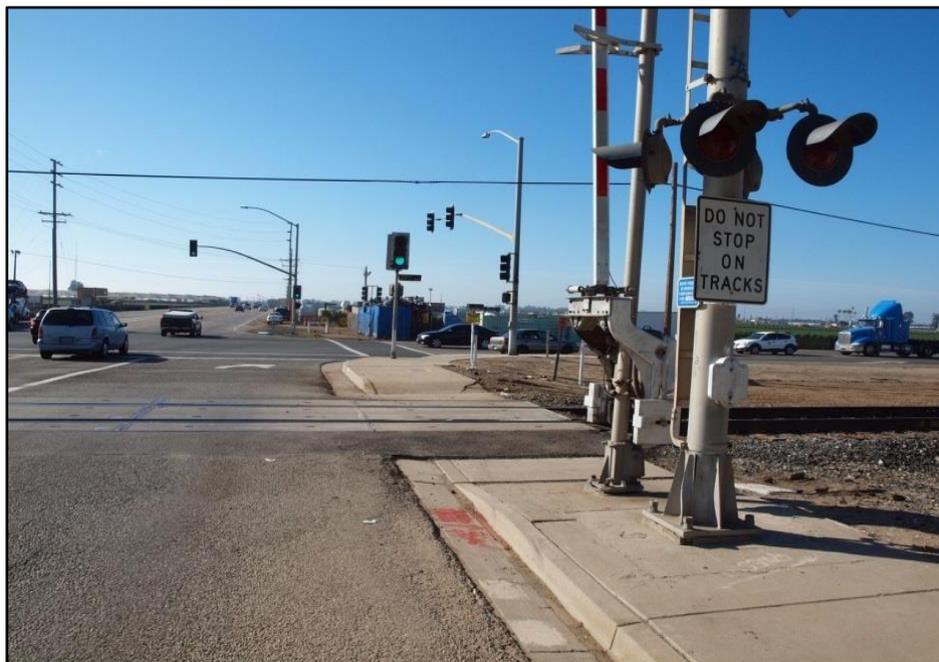
In Oxnard, the truck driver traveled south on South Rice Avenue on approach to the intersection with East Fifth Street, which is located just 57-feet beyond the railroad grade crossing. This protected highway–railroad at-grade crossing is marked by a combination of warning lights, gates, signs, and pavement markings (figure 4). ~~(No mention here about the deteriorating conditions in February 2015, with road markings either worn or non-existent, especially at the actual grade crossing)~~ According to the driver, he had intended to turn right at the intersection and to proceed west on East Fifth Street; however, he turned his vehicle too soon and entered the railroad right-of-way.

Figure 4 (Above). View of southward approach to East Fifth Street from right lane of South Rice Avenue, with grade crossing in foreground, 57 feet from East Fifth Street. (Subsequent to the February 2015 collision.)

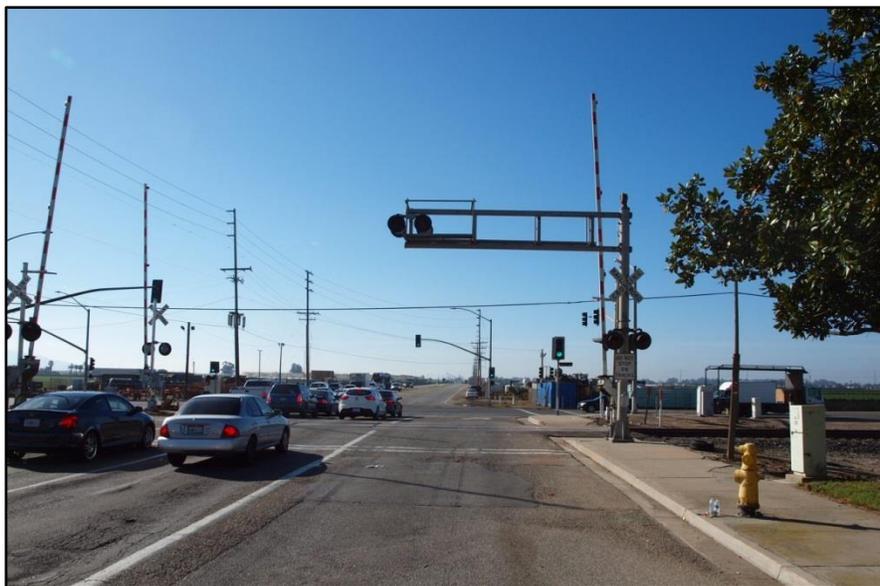
Figure 8 shows the approach to the intersection from South Rice Avenue. The distance from the nearest rail to the nearest point of the intersection is about 57 feet. On the southbound approach to the grade crossing, parallel white stop lines are located 11 feet from the automatic gate arm; on the northbound approach, parallel white stop lines are located 5 feet from the gate arm. Thirty-foot-high LED street lights are located on each quadrant of the intersection. The streetlights were tested on February 26, 2015, and found to be in full working order and performing as designed.

Figure 8. View of southbound approach to East Fifth Street intersection from right lane of South Rice Avenue. (Prior to postcrash “improvements”).

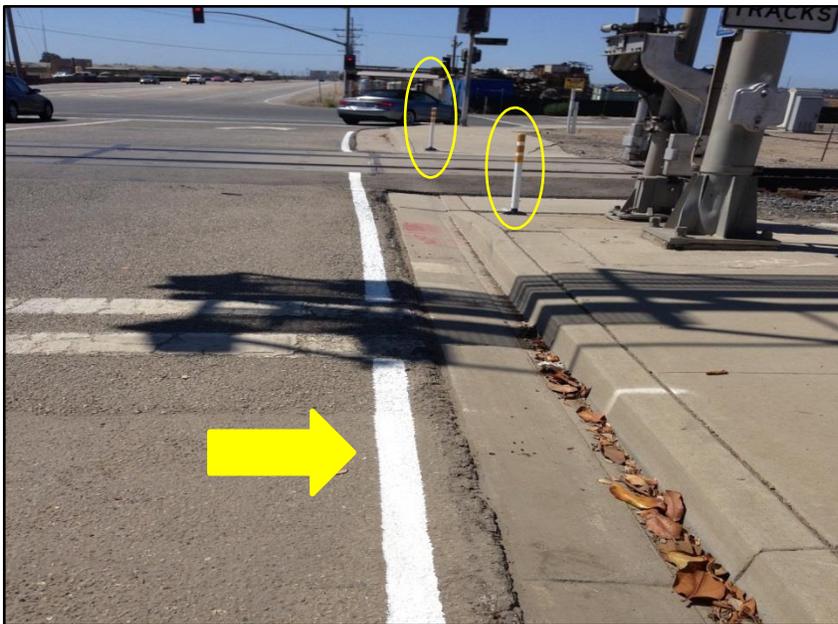
Photo above taken December 6, 2016, by James McGillis. Other than installation of the two traffic delineators installed near the tracks, conditions at the Rice Avenue grade crossing are more decrepit and deteriorated than any time since the 2010 train collision at this spot.
