PRELIMINARY REPORT

HIGHWAY

HWY15MH006

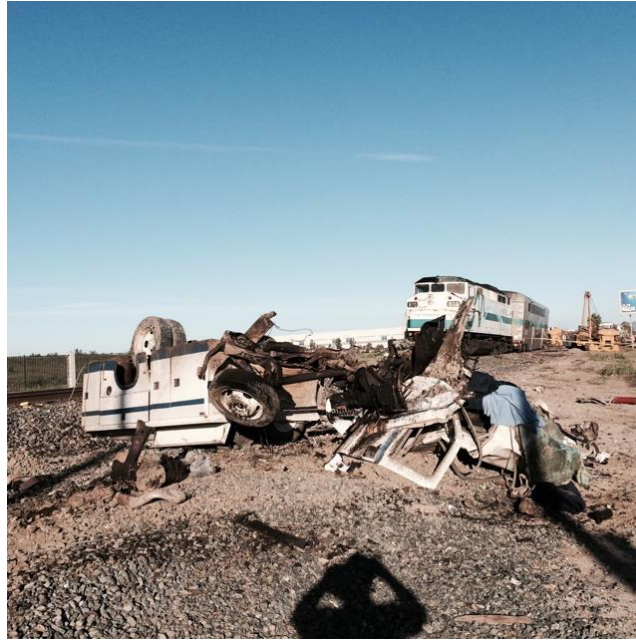
⁹ Emergency responders determined that the truck cab, which was found in a severely crushed condition, had been unoccupied.

Ford F-450 truck at final rest.
